MEMORANDUM

To:	Gary Miller and Anne Foster U.S. Environmental Protection Agency	Date:	November 18, 2015
From:	John Laplante, John Verduin, Wendell Mears, and David Keith, Anchor QEA	Project:	090557-01.06
Cc:	Phil Slowiak, IP David Moreira, MIMC		
Re:	Post-TCRA Semi-Annual Inspection Report – October 2015

This document reports the results of the October 2015 inspection of the armored cap cover, fencing, and signage installed for the Time Critical Removal Action (TCRA) at the San Jacinto River Waste Pits Superfund Site (TCRA Site).

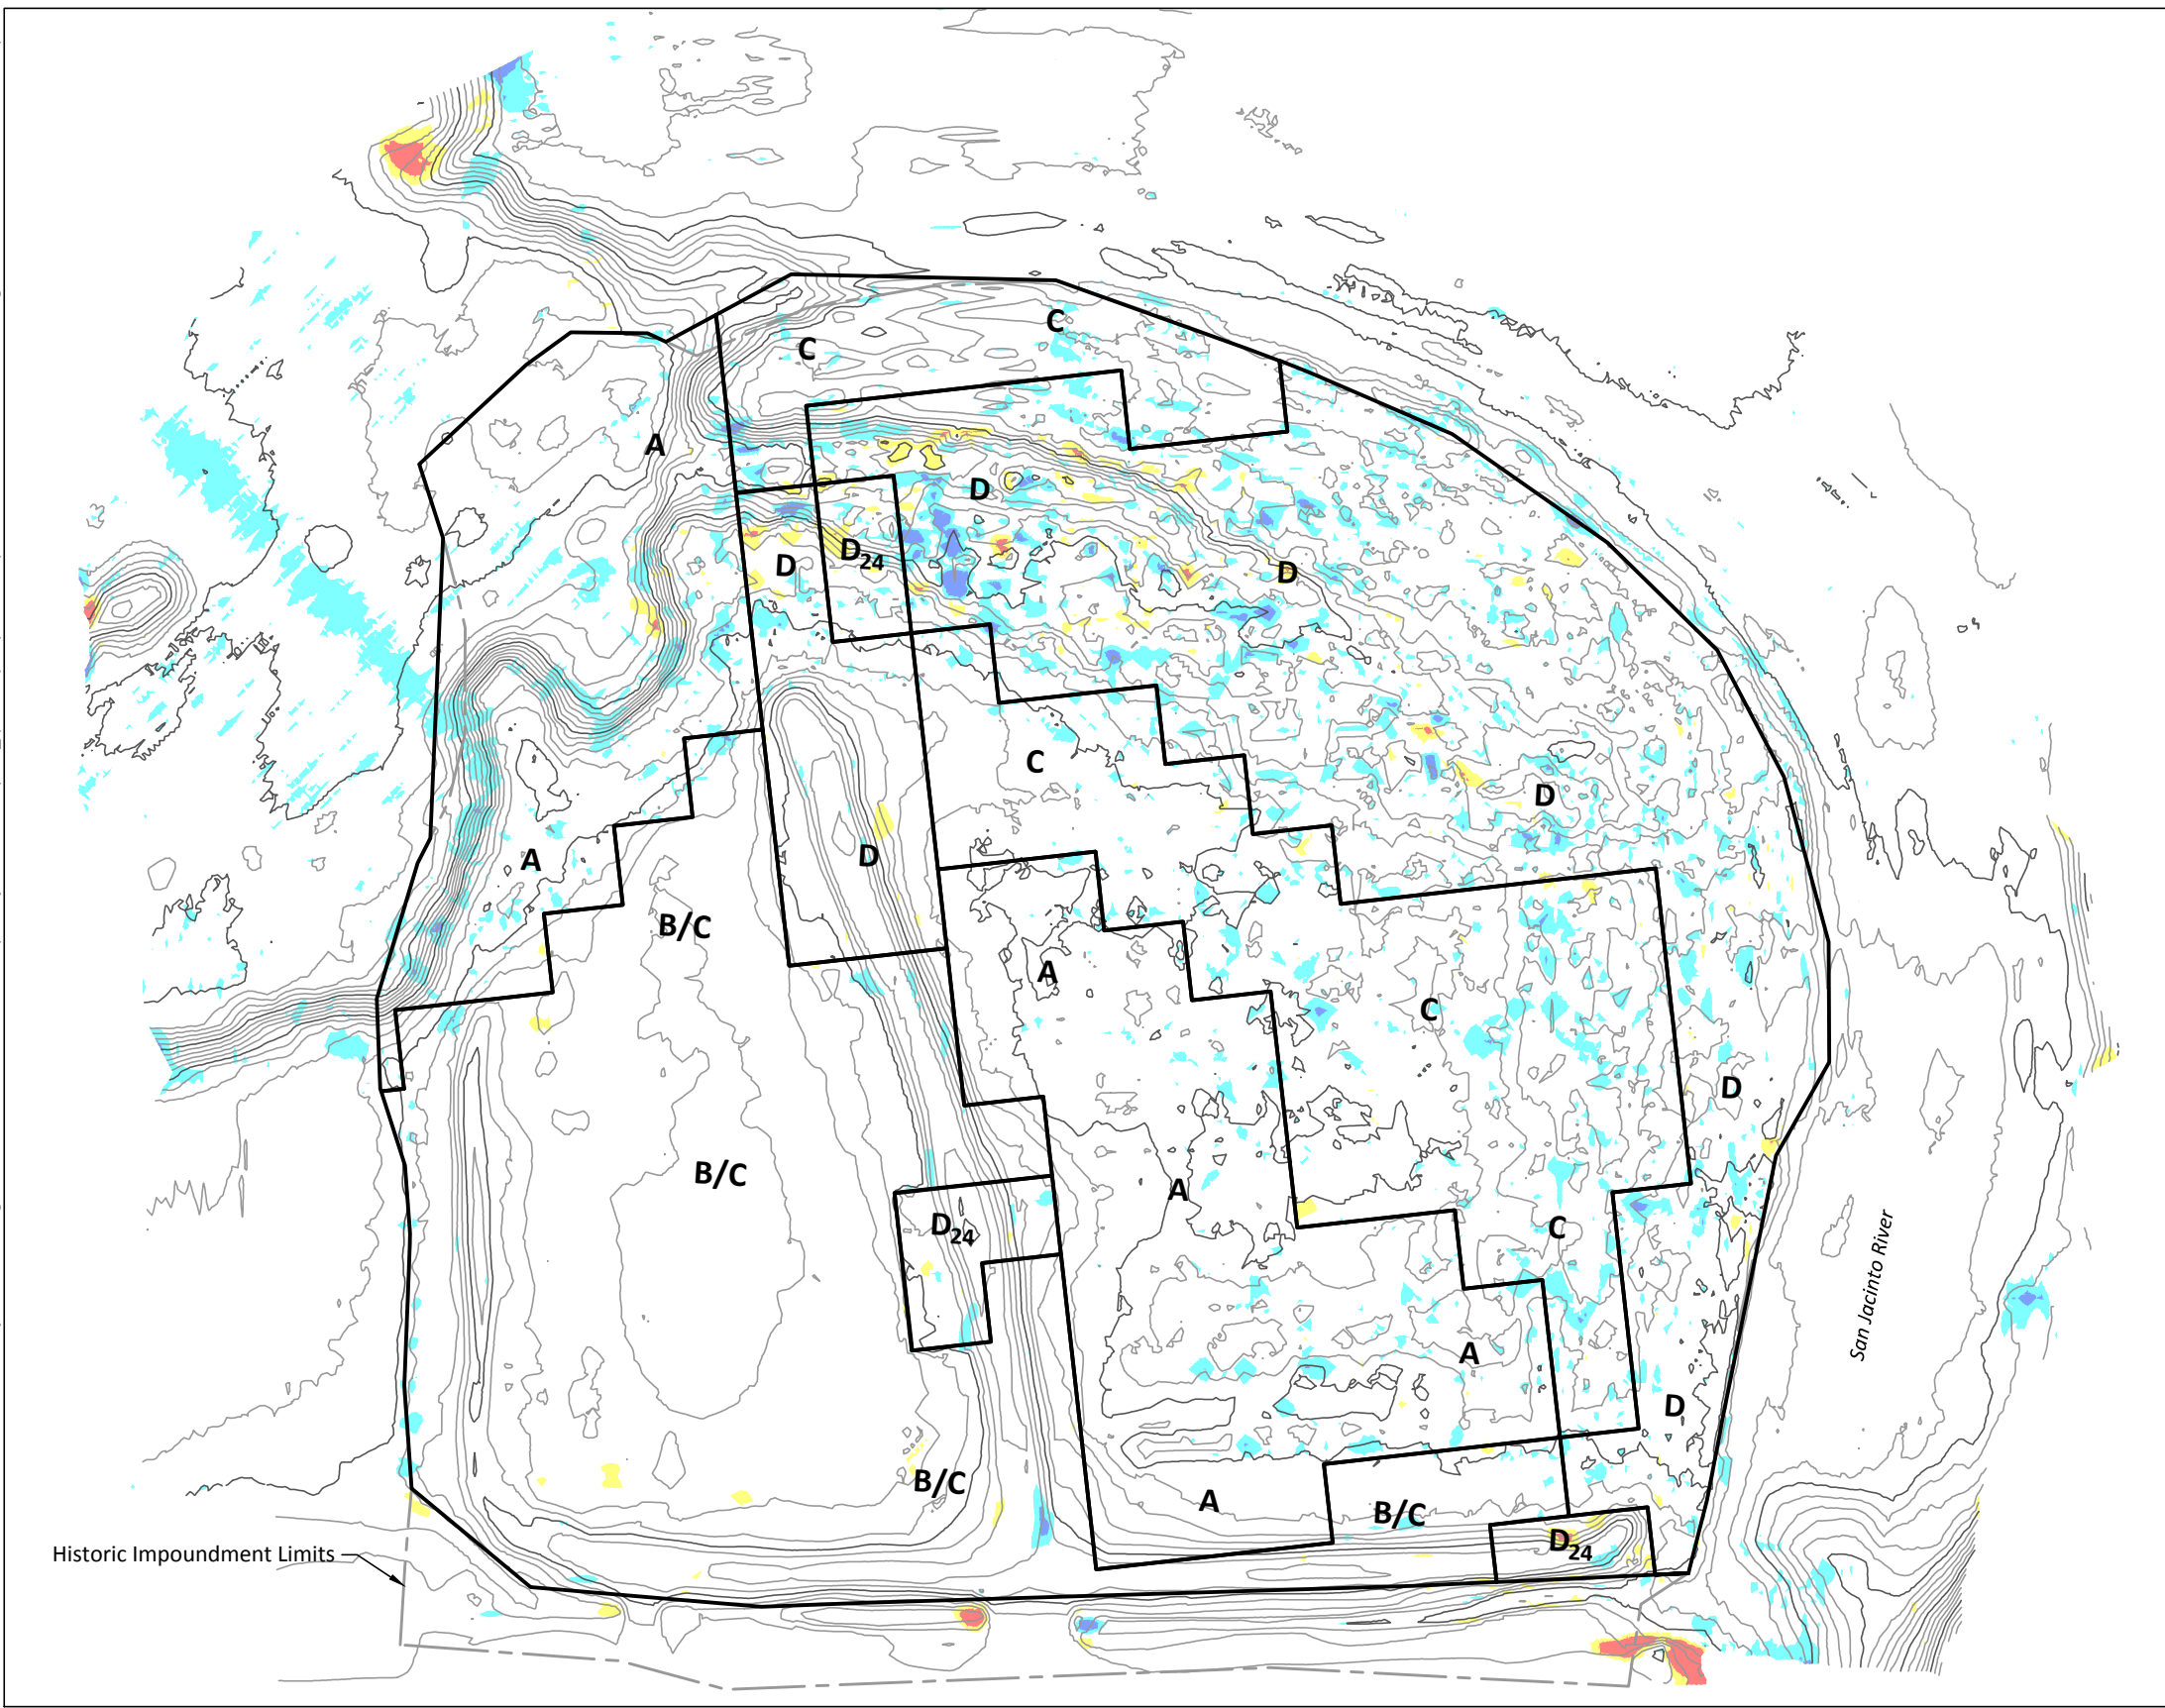
The survey data from the October 2015 inspection survey and the July 2015 surveys were compared to evaluate the differences in the top of the armored cap elevation. These differences are shaded and shown on Figure 3. The survey results indicate continued sedimentation/deposition on the surface of the armored cap in submerged areas.

Manual probing of armored cap thickness is required at areas identified by the topographic or bathymetric surveys as more than 6 inches lower in elevation than during the prior survey over contiguous areas of 30 feet by 30 feet. When the October 2015 and July 2015 surveys were compared, the results indicated that there were no areas that met the manual probing requirement. Therefore, no probing was conducted as part of the October 2015 inspection.

The small areas identified as increases and decreases in elevation can be attributed to the horizontal and vertical limitations of the survey, minor shifts in track line location from the baseline survey, and elevation data recorded in the crevices between rock surfaces or atop shellfish growth. The potential for these types of variations between the two datasets to exist was confirmed by the surveyor after reviewing the data collected during this inspection.

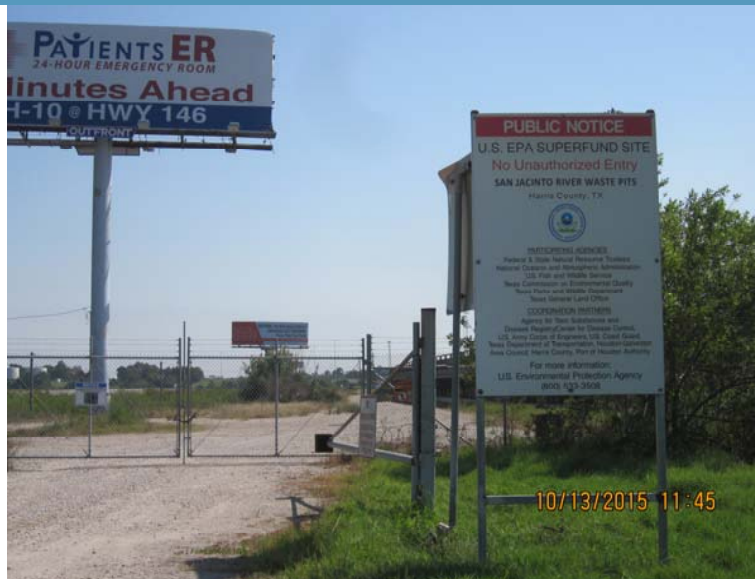
3) at the end of the TxDOT right-of-way north of I-10 near the San Jacinto River. For examples, see Photographs 1, 4, and 15 in Appendix A. These three signs were observed to be in place and undamaged.

Signage on all locked gates reminds entrants to “daisy chain” the locks properly prior to leaving the TCRA Site, as seen in Photograph 1. These signs were observed to be in place and undamaged.

Photograph 01: USEPA Public Notice Sign located outside access gate north of I-10 (view east)

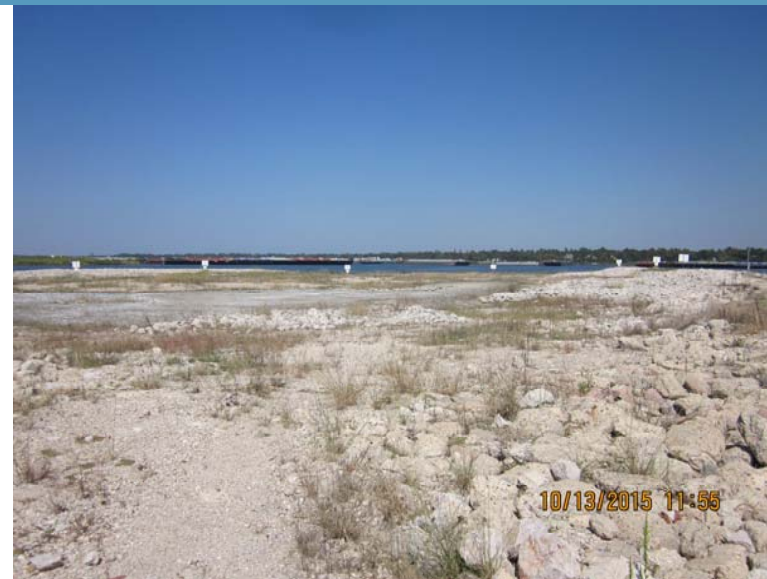
Photographs of the armored cap from the inspection event are provided in Appendix A (see Photographs 2 through 11). The majority of the Eastern Cell armored cap was underwater at the time of the initial inspection. All of the visible portions of the armored cap were observed to be intact, and no movement of cap materials was observed at any location. A subsequent visual inspection occurred on October 26, 2005 and is discussed below.

Photograph 02: Interior of Western Cell (view northwest)

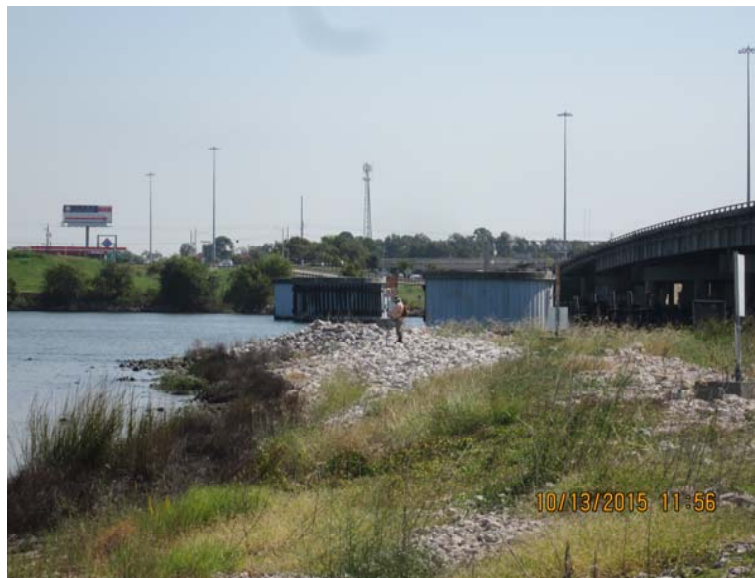
Photograph 03: Hydrographic Consultants performing topographic survey on southern berm (view east)

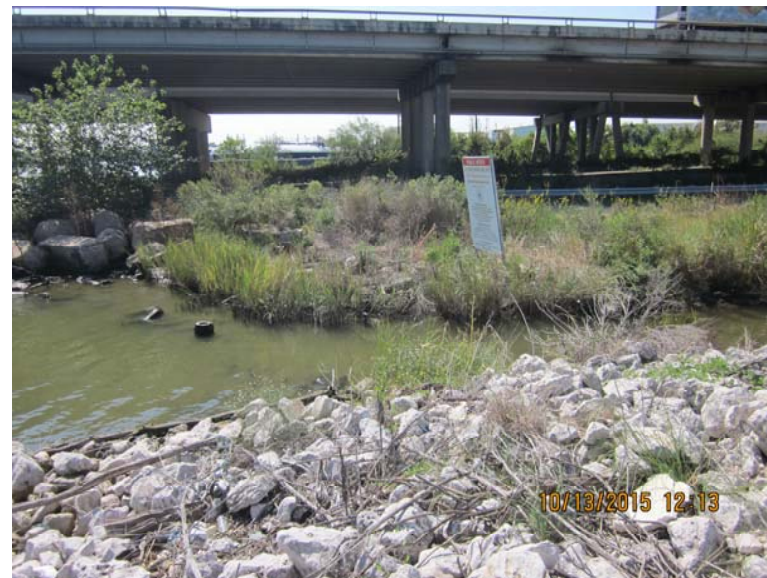
Photograph 04: USEPA Public Notice Sign located north of I-10 on west bank of San Jacinto River (view south)

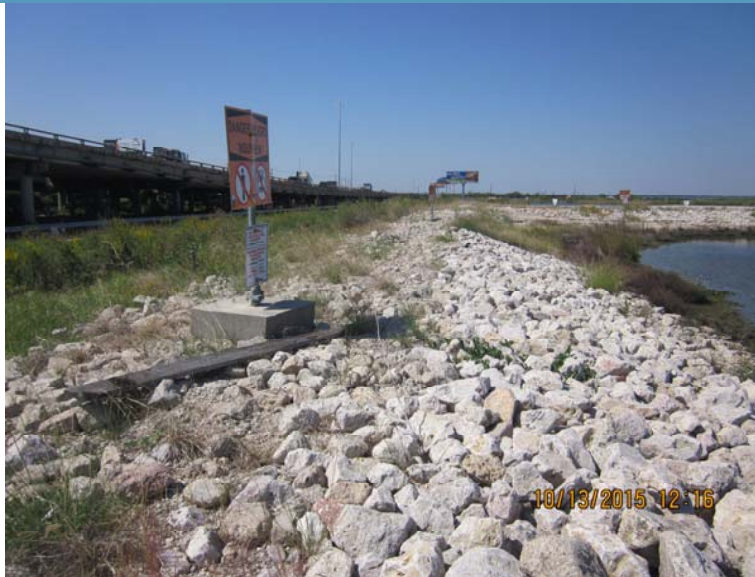
A total of fifteen signs were installed at the TCRA Site around the perimeter of the land portion of the TCRA Site; the signs are mounted on steel posts and set in concrete pads. For examples, see Photographs 5 through 8 in Appendix A. These signs are intended to face the San Jacinto River to deter water-based entry to the TCRA Site. A few of these signs had rotated out of proper alignment due to the wind, and the affected signs were re-aligned to the intended viewing perspective.

Photograph 05: Warning signs along southern berm (view west)

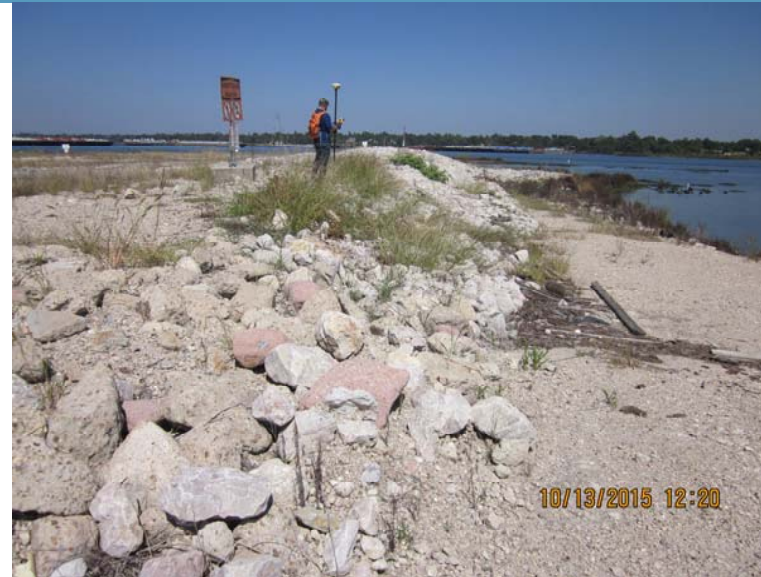
Photograph 06: Hydrographic Consultants performing topographic survey on central berm (view north)

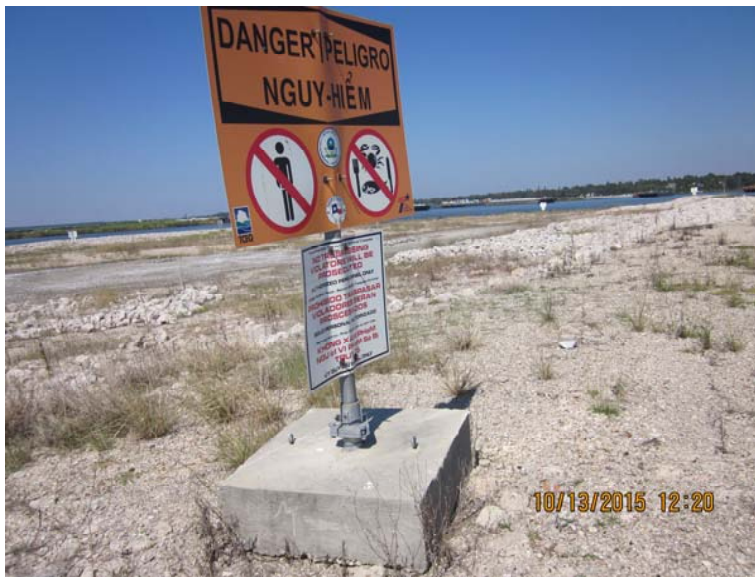
Photograph 07: Warning sign along central berm (view northwest)

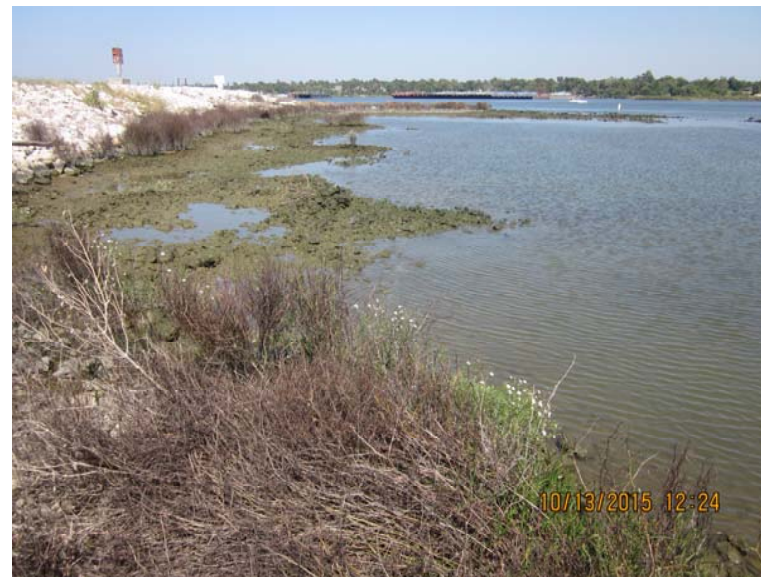
Photograph 08: Warning signs along western berm and Eastern Cell (view north)

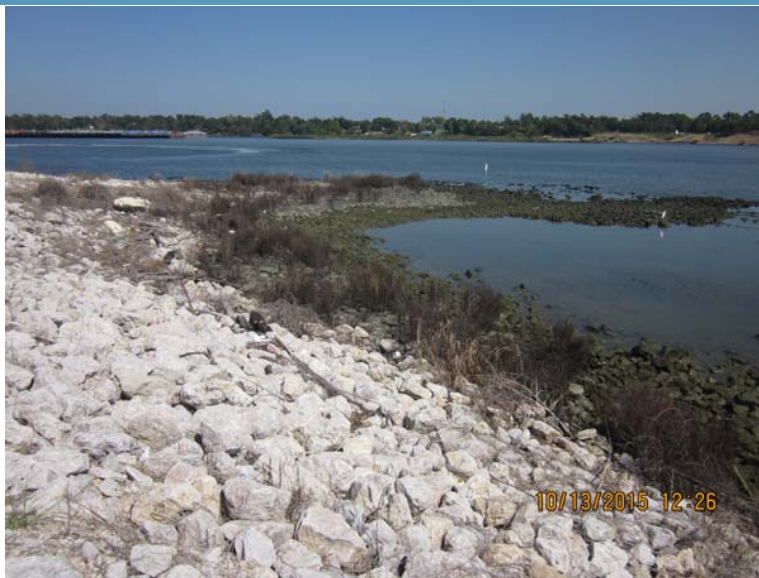
Photograph 09: Central berm and Eastern Cell (view northeast)

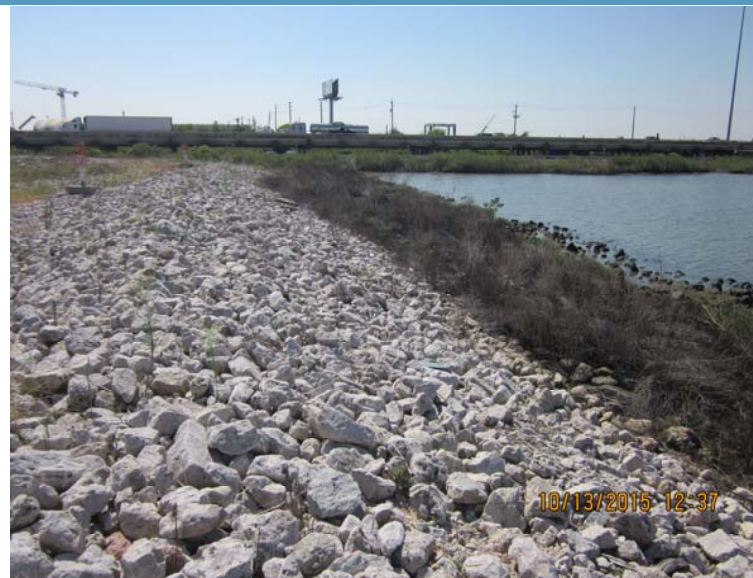
Photograph 10: Warning signs along western berm (view south)

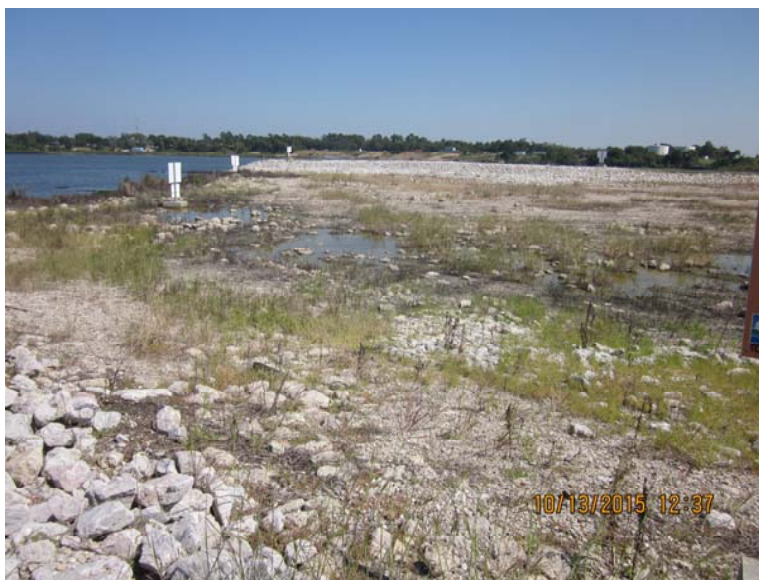
Photograph 11: Interior of Western Cell (view northeast)

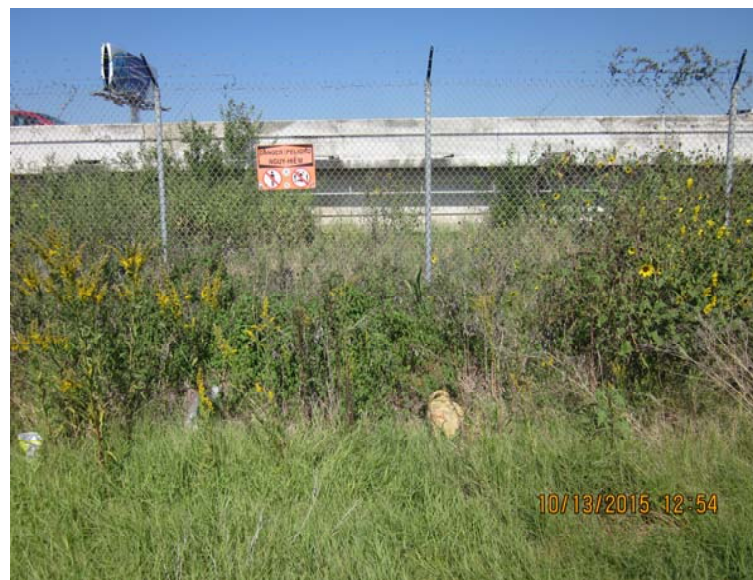
The perimeter fencing on the west and east banks of the San Jacinto River was visually inspected for breaches or other signs of damage. No breaches or other signs of fence damage were observed during the inspection for any of the three sections of the fence: the east bank, the west bank on the north side of I-10, or the west bank on the south side of I-10. For examples, see Photographs 12 and 14 through 16 in Appendix A.

"Danger" and "No Trespassing" signs are posted at regular intervals on the perimeter fencing surrounding the TCRA Site. For examples, see Photographs 12 and 14 in Appendix A. These signs were observed to be in place during the October 13, 2015 inspection.

Photograph 12: Signage and perimeter fencing south of I-10 on west bank (view north)

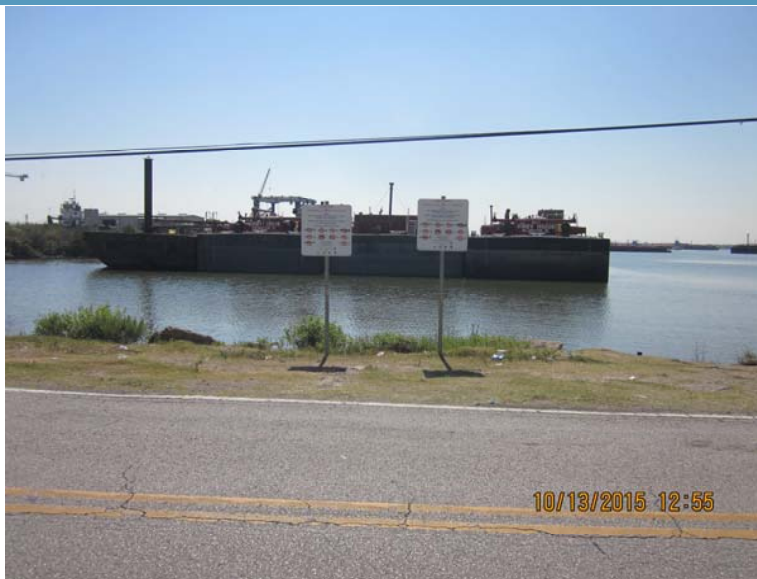
Photograph 13: Fish consumption advisory signs south of I-10 on west bank (view south)

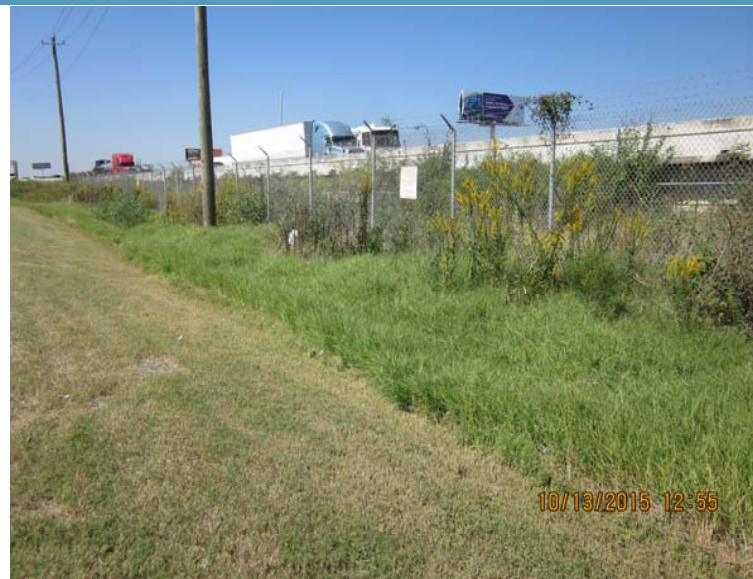
Photograph 14: Signage and perimeter fencing south of I-10 on west bank (view northwest)

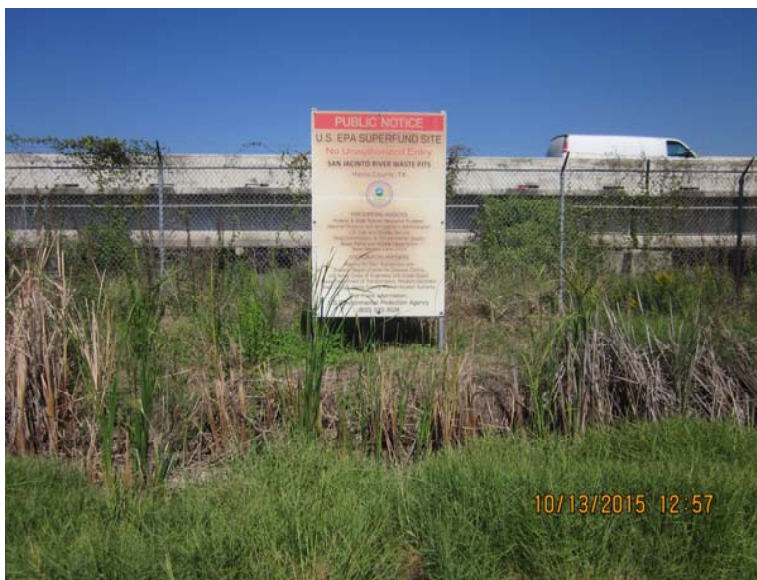
Photograph 15: USEPA Public Notice Sign south of I-10 on west bank (view north)

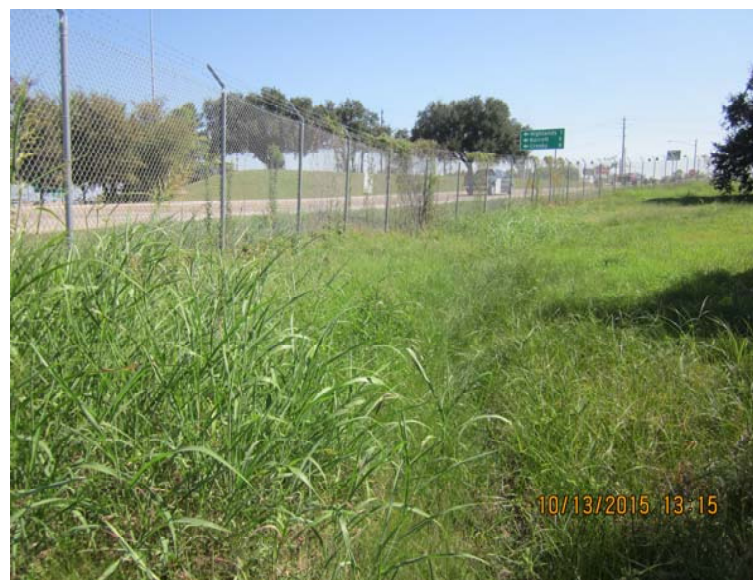
Photograph 16: Perimeter fencing south of I-10 on east bank (view northeast)

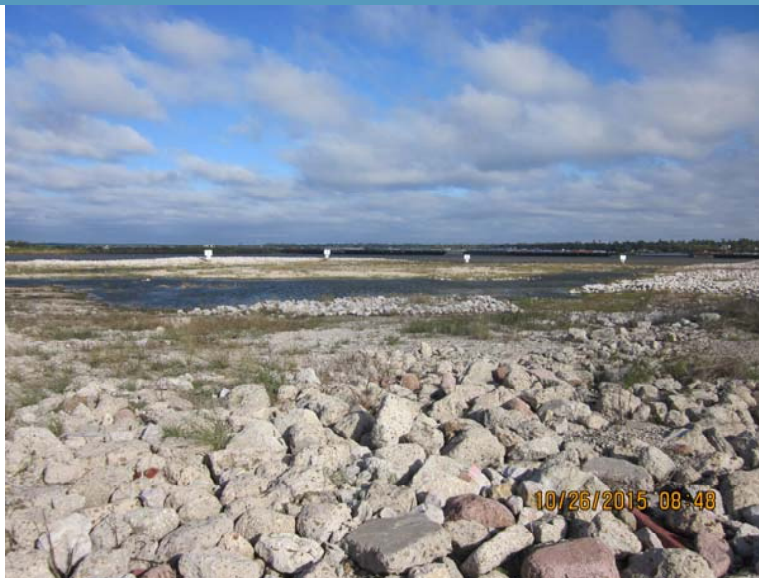
A voluntary visual inspection was performed on October 26, 2015 after two days of heavy rainfall. Nearly 8 inches of rain fell in the area on October 24 and 25, 2015, but the stage height at Lake Houston Dam stayed well below the 10-year flood level. The majority of the Eastern Cell was visible above the water level during the visual inspection. No movement of cap material was observed. See Photographs 17 through 20 for site conditions after the storm.

Photograph 17: Interior of Western Cell after heavy rainfall on October 24-25, 2015
(view northwest)

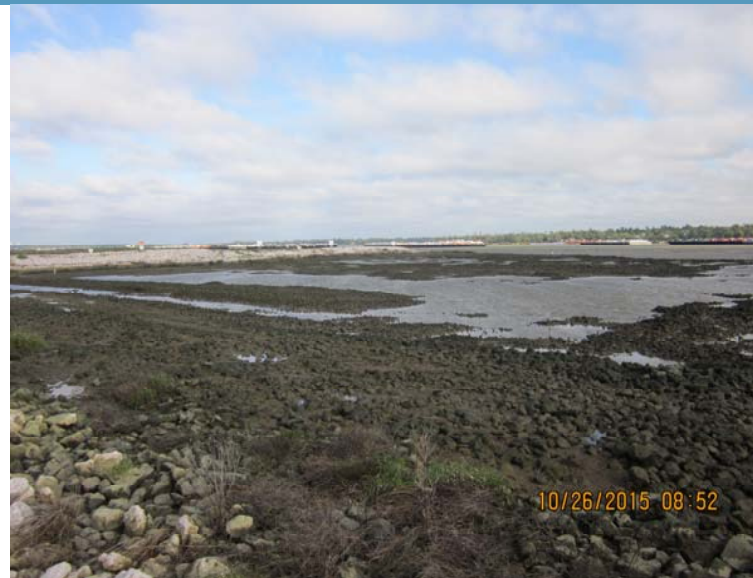
Photograph 18: Eastern Cell after heavy rainfall on October 24-25, 2015
(view northwest)

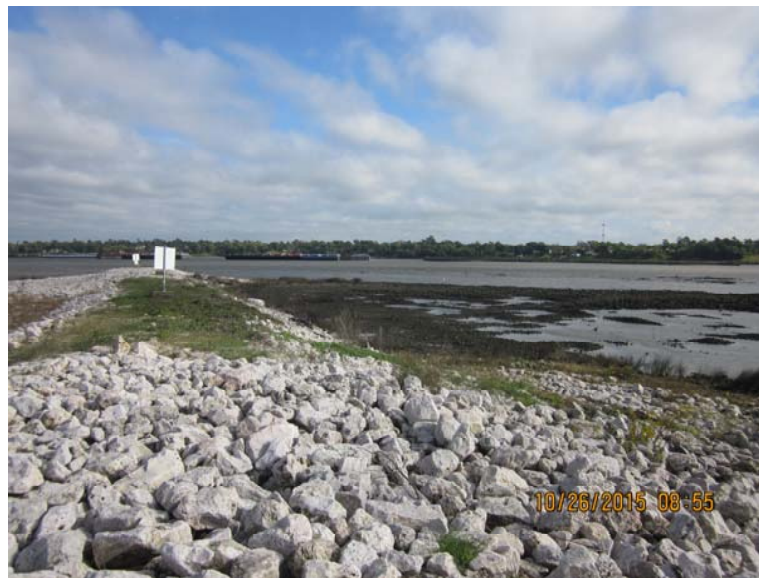
Photograph 19: Central berm after heavy rainfall on October 24-25, 2015
(view north)

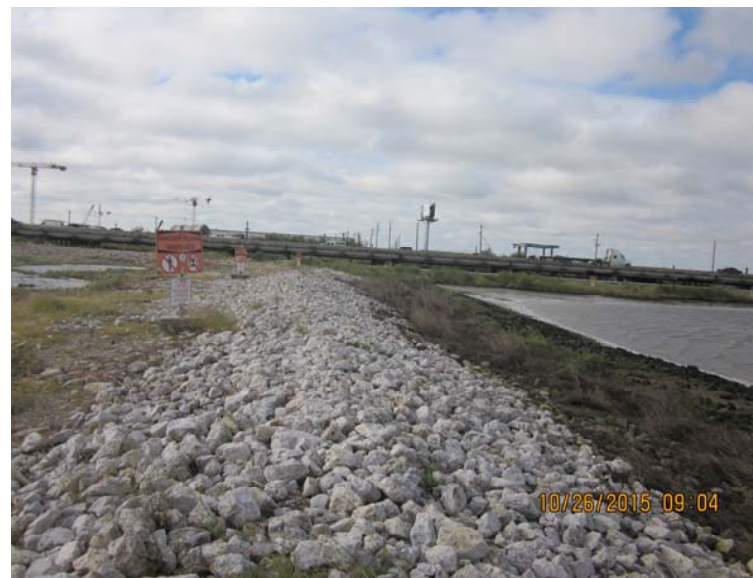
Photograph 20: Western berm after heavy rainfall on October 24-25, 2015
(view south)
